*U.S. Department of Energy
Office of Legacy Management*

2006 Annual Site Inspection and Monitoring Report for Uranium Mill Tailings Radiation Control Act Title I Disposal Sites

December 2006

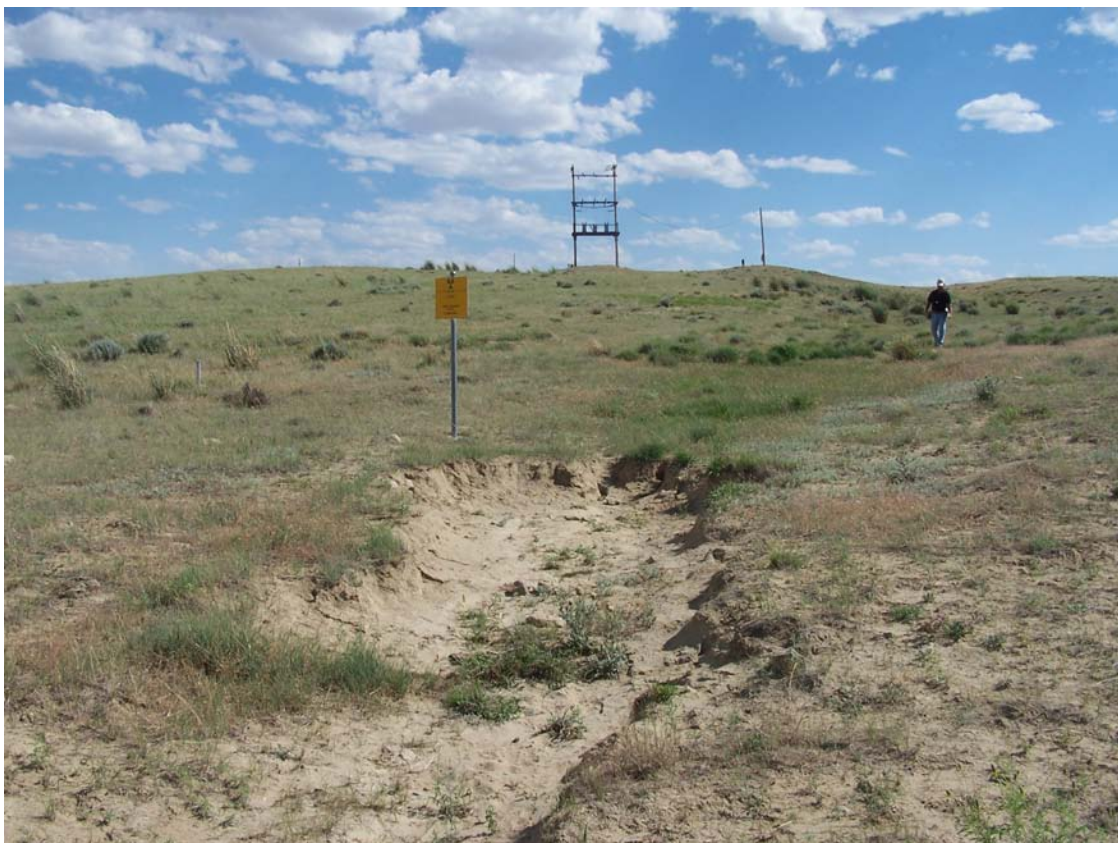
SPK 6/2006. PL-4. Erosion near perimeter sign P4.
